# A BRIDGE BROKEN

## How Did the Morrison Bridge Become Such an Expensive, Dangerous Mess? Newly Public Documents Suggest It Had a Lot of Help

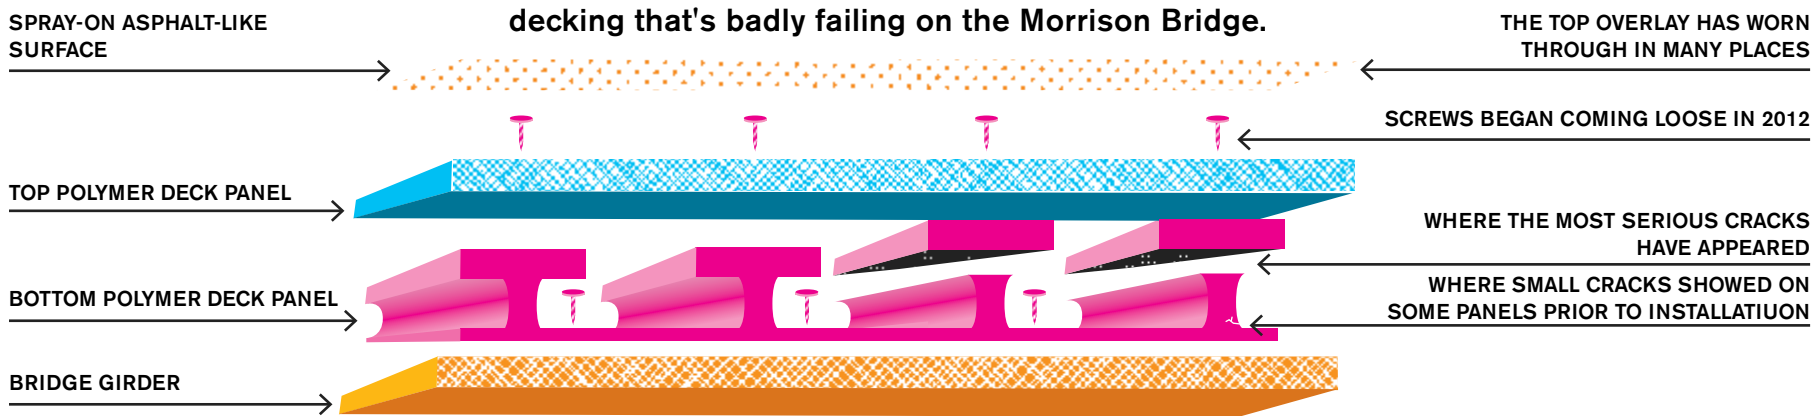
**COMING UNDONE:** Here's a cross-section of the semi-experimental decking that's badly failing on the Morrison Bridge.

In October 2011, with deck installation already underway, the county began to voice worries about thin cracks that were showing up along the base of crucial supports in the polymer panels.

The argument Strongwell and ZellComp would wind up making—to county officials and in court papers—is that the cracks weren't important. To this day, they don't even call them "cracks" if they can help it. To the companies, the distressing-looking seams were something called "crazes," harmless irregularities that sometimes show up in the type of polymer used on the Morrison.
